# **CORTEX DENTAL IMPLANTS SYSTEM**

## **Clinical Case Report**

Cortex Dental Implants Industries Ltd

06 - 26 - 2012

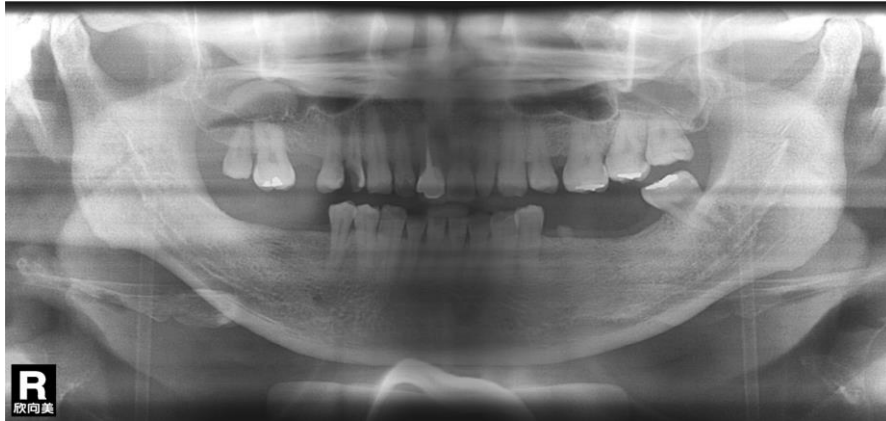
PRE OP full view: upper and lower dentition defect,  
16, 25, 35, 36, 37, 46, 47 were missing, 11 root tip pathological changes, implantation except 25

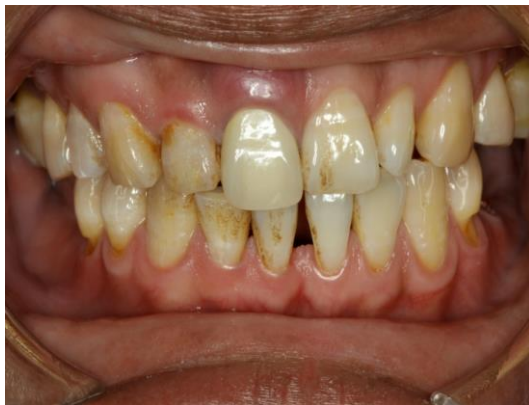
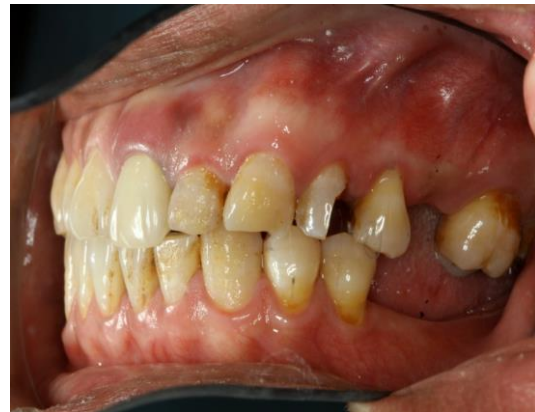
PRE OP photo inner oral

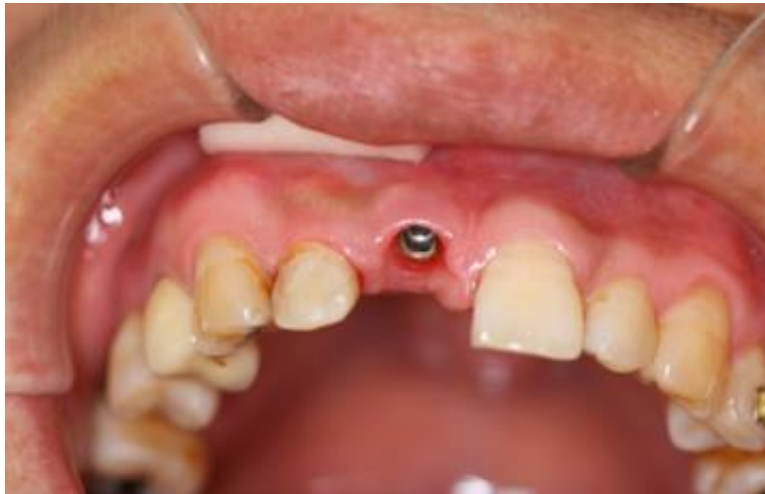
15 weeks post op, implant cuff molding, smooth and mellow. No red and swollen symptom of inflammation, no material fragment slop over

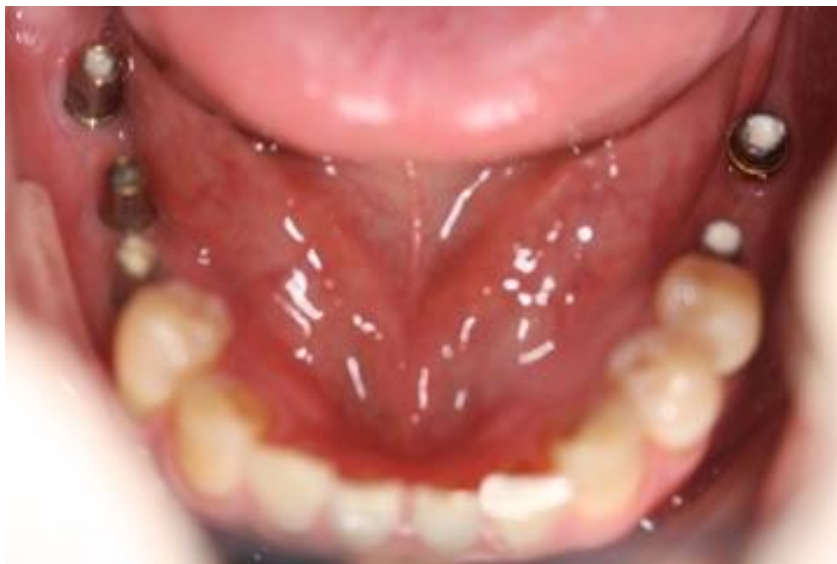
15 weeks post op, soft tissue surround drill base on lower jaw healing nice, no inflammation and fragment. Bone integration tightly

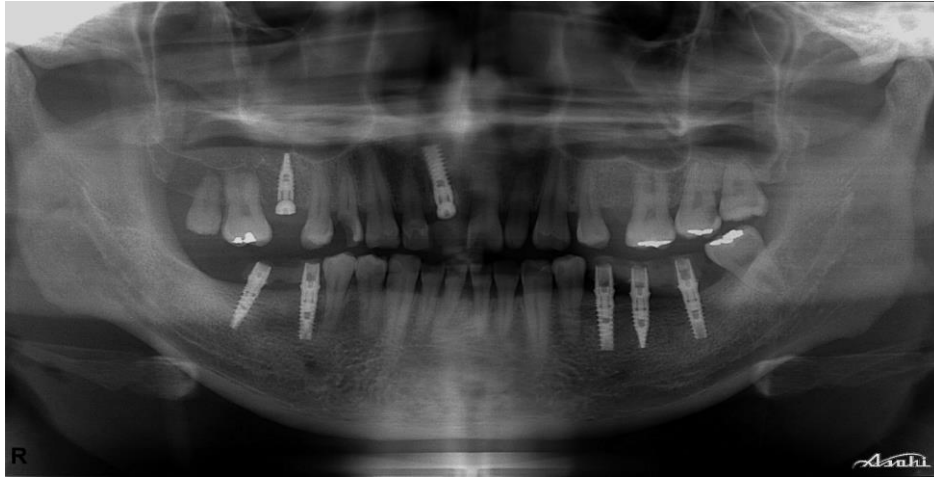
POST OP full view, bone integration nice and no obvious bone resorption

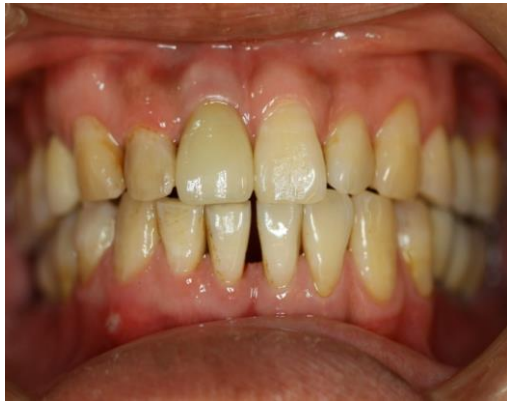
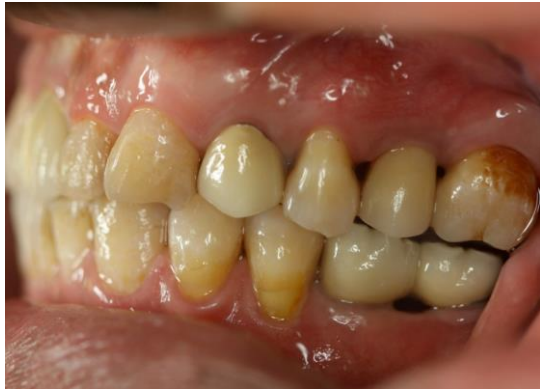
After denture implantation, neck age healing in health, no attachment recession and inflammation

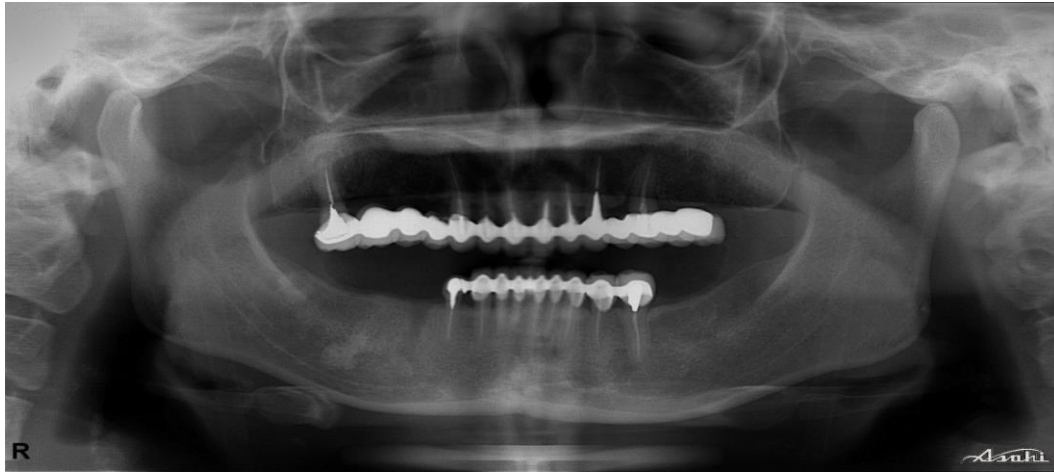
Full view - upper and lower dentition defect

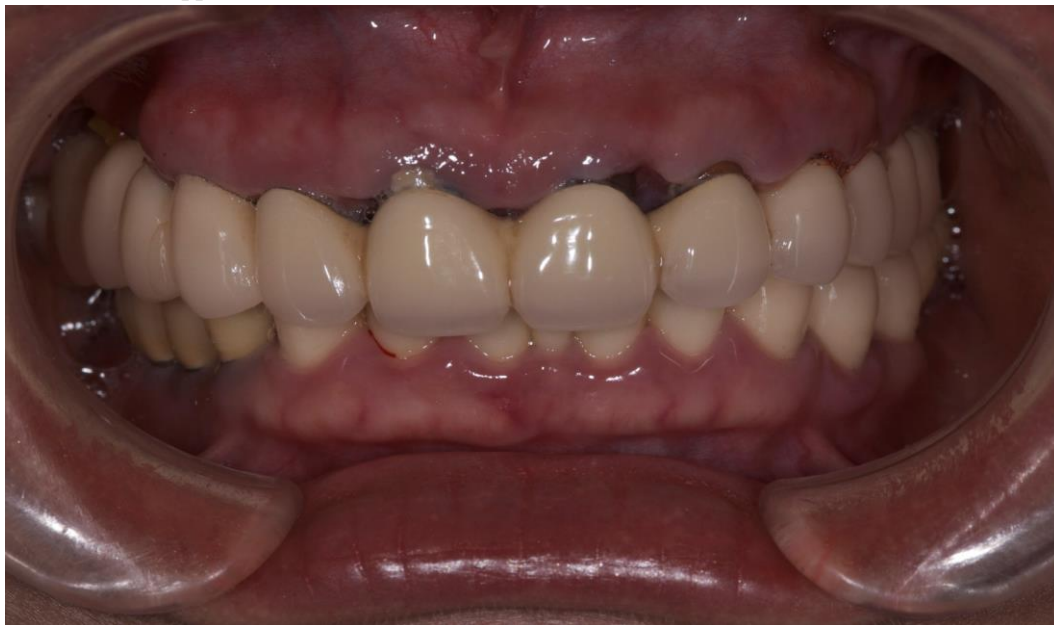
Whole mouth unhealthy implantation. Remove and reform, missing position implantation

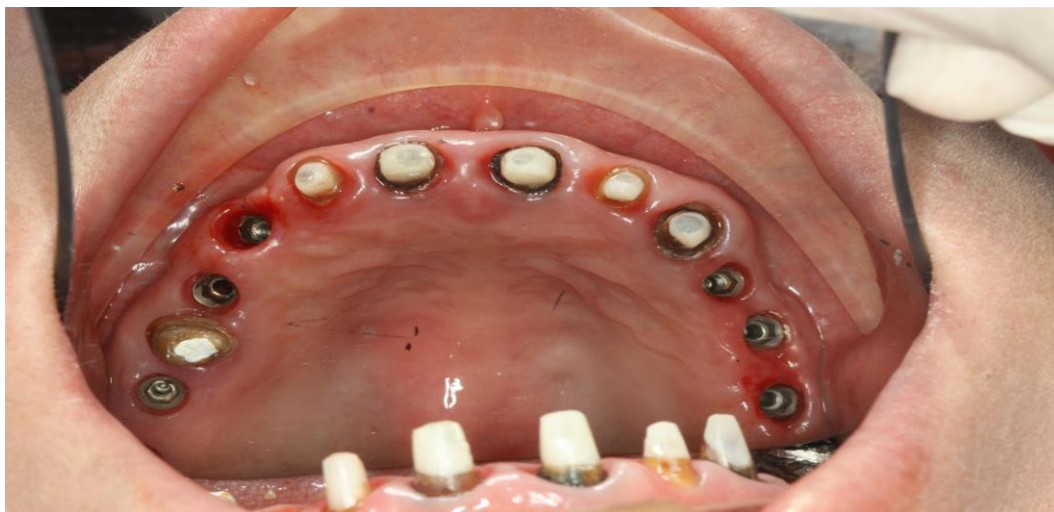
After 14 weeks, implant cuff molding, smooth and mellow. No symptom of inflammation, no material fragment

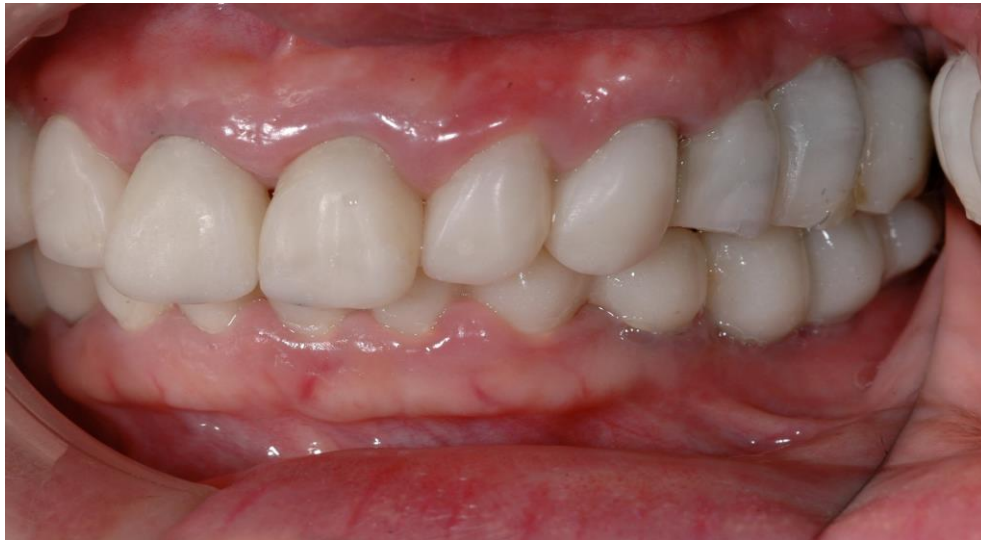
Upper repair complete, gingiva healing in healthy, no inflammation

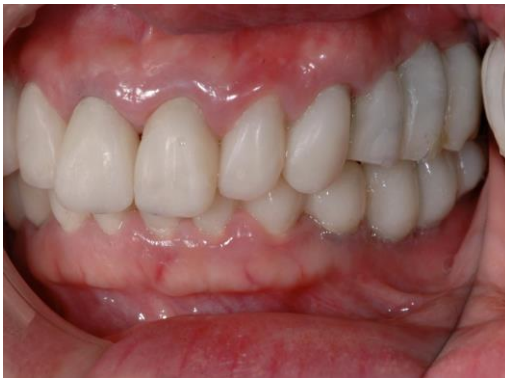
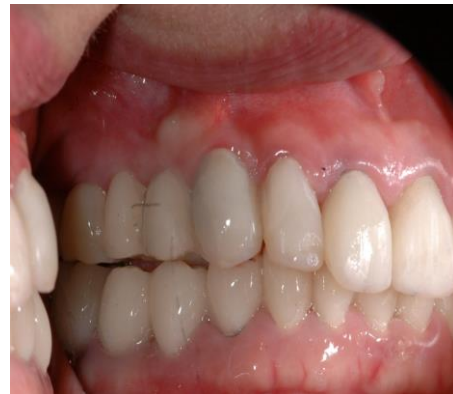
After denture implantation gingiva around implant healing nice and had not inspected inflammation

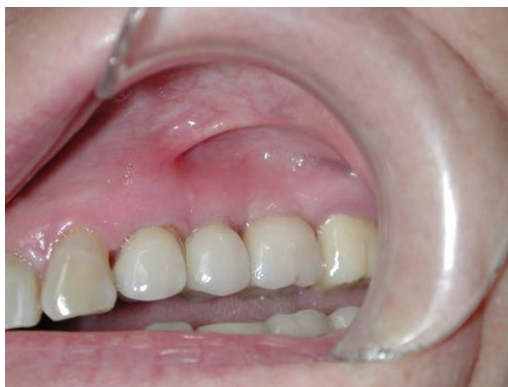
**X-ray and Photo 20 months post Implantation**

No bone loss and healthy soft tissue. Note the nice recovery and healing of the papillae , especially between 23 & 24

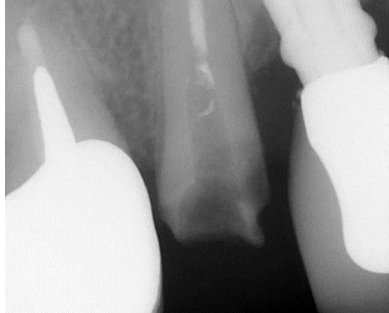
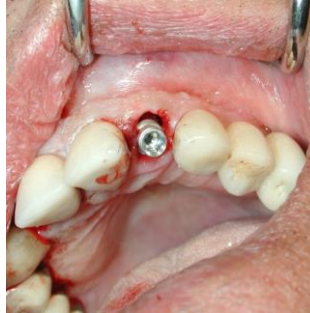
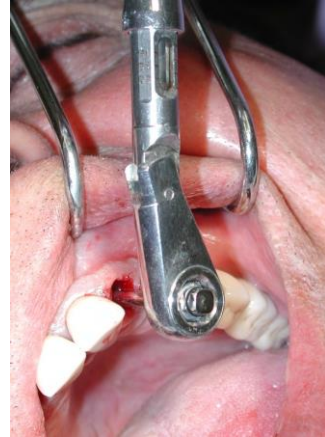
### X-ray and temporary crown on day of implantation

Note the radiolucent lesion caused by the extracted 22 socket

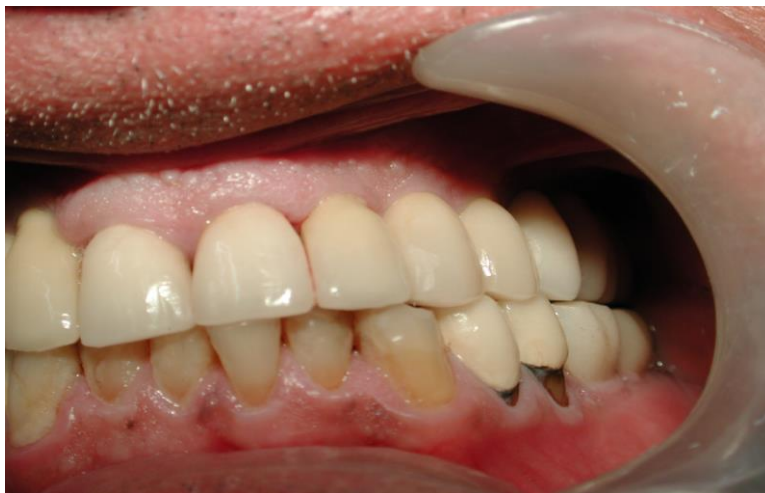
### 23 months post implantation

Note the healthy soft tissue . Papillae without recession and complete healing of the lesion.

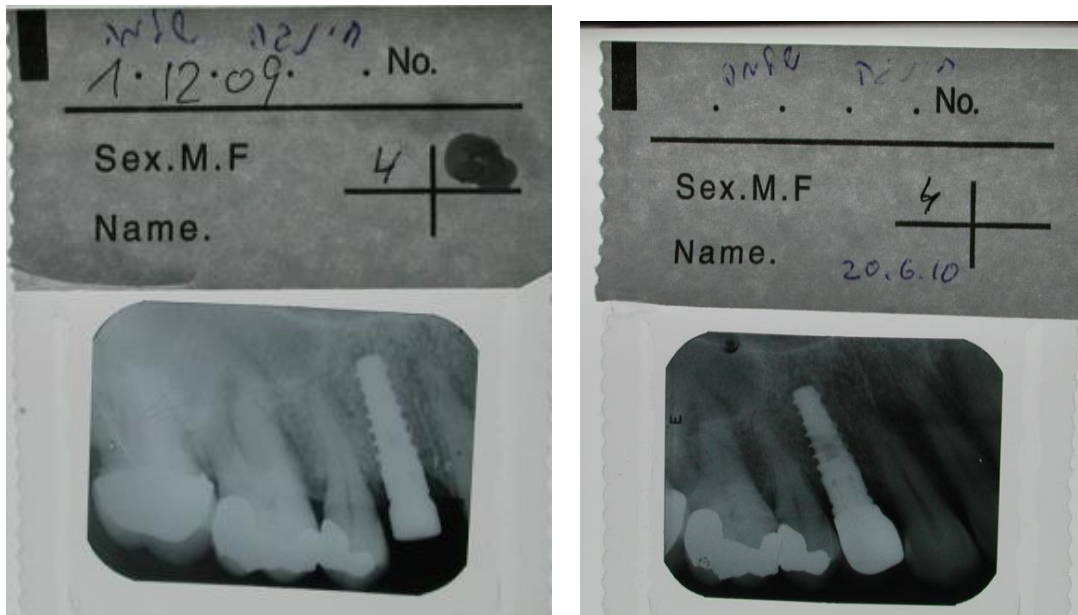
14 implant – 12 months later

Bone integration in good situation, had not inspected inflammation symptom around implant, no fibrosis/fibrous capsule, no degeneration as determined by changes in tissue morphology, etc.

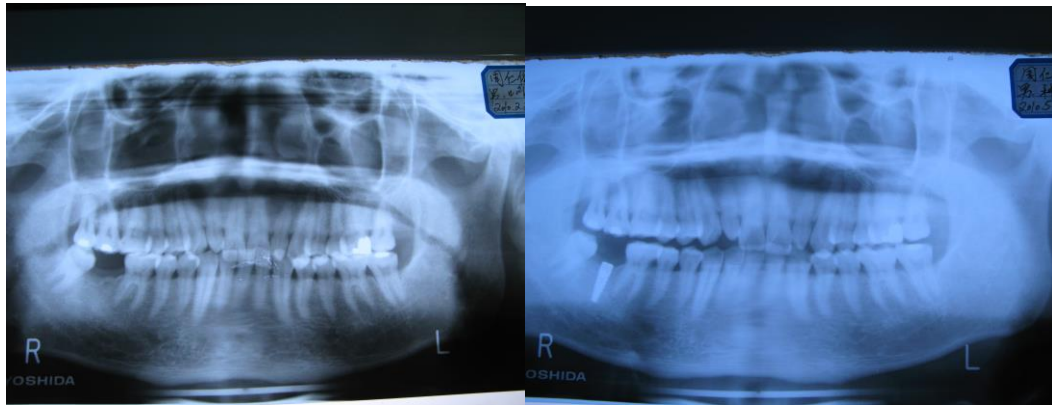
47 was missing, implantation.

12 weeks after surgery, bone integration in good situation, had not inspected material fragment, inflammation cell, fatty infiltration, granuloma, etc.

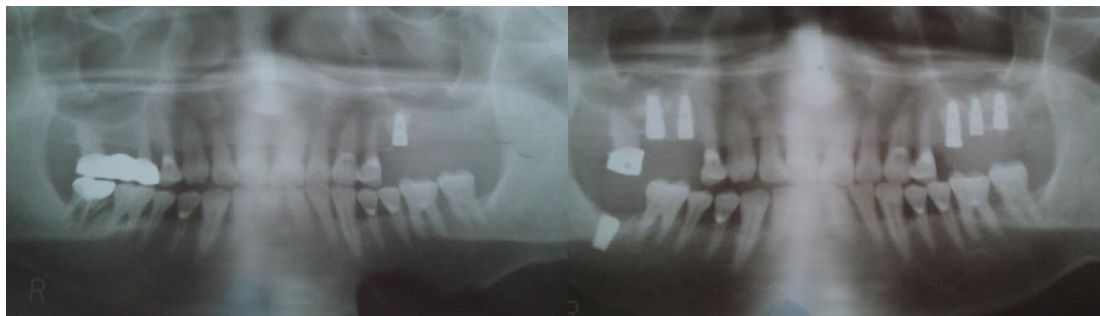
15-17 bridge repair, 16 was missing, remove and implantation. 25 earlier stage implantation, 26, 27 bone mass insufficient, sinus lifts and implantation in the corresponding period. 47 periodontitis, alveolar absorb, remove and implantation. 18 weeks after surgery, bone integration in good situation, around implant had not inspected material fragment, fatty infiltration, granuloma, etc.

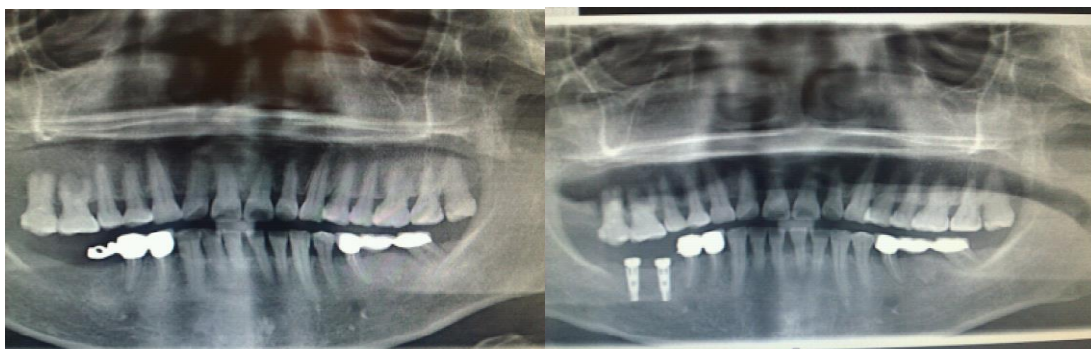
44, 45 bad single-ended prosthesis, 46, 47 were missing, remove, 46, 47 implantation. 13 weeks after surgery, bone integration in good situation, around implant and drill base had not

inspected inflammation symptom, material fragment, fatty infiltration, granuloma, etc.

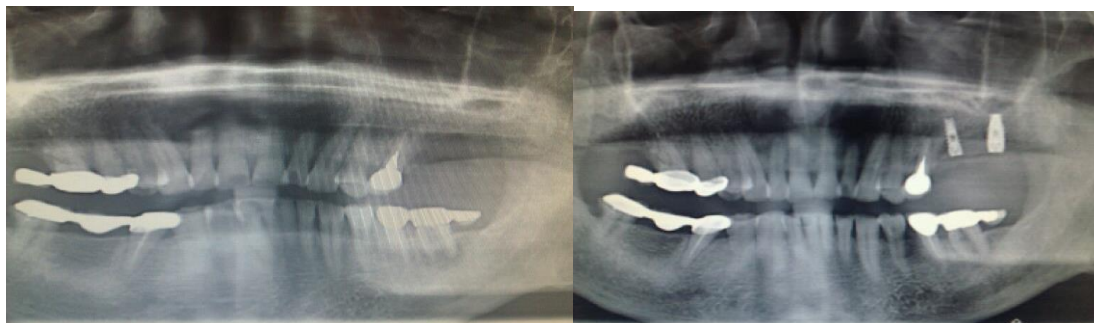
26, 27 were missing, dental implantation.

16 weeks after surgery, around implant no adverse reaction, fibrosis/fibrous capsule, tissue necrosis, fatty infiltration, granuloma, etc.

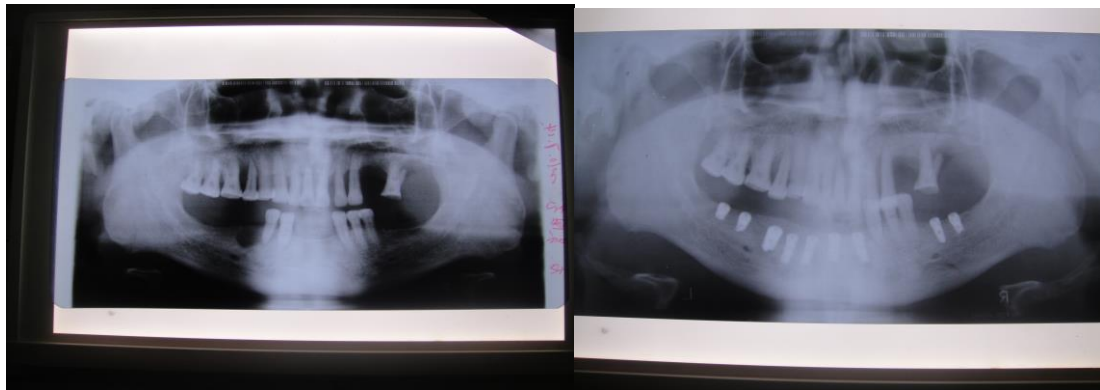
24, 25, 27, 28, 31, 32, 36, 37, 38, 41, 44, 45, 46, 47, 48 were missing; 31, 36, 37, 41, 42, 43, 44, 46, 47 implantation. 20 weeks after surgery, around implant no adverse reaction, fibrosis/fibrous capsule, tissue necrosis, fatty infiltration, granuloma, etc.

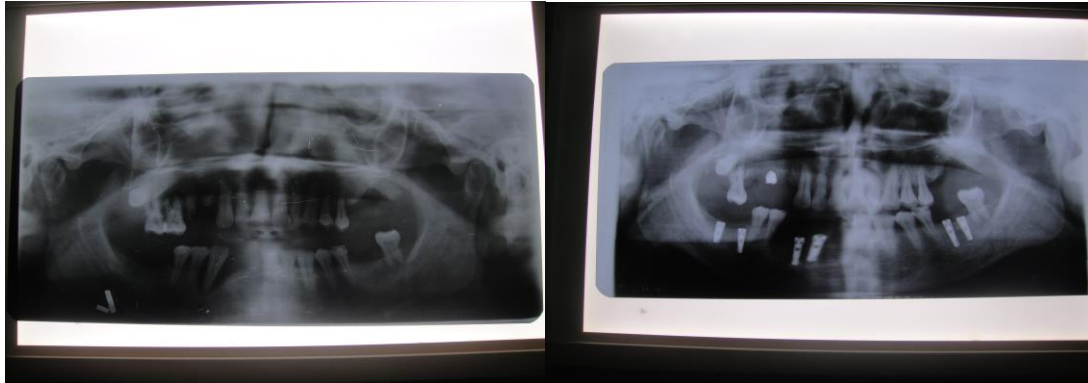
14, 15 residual root, 26, 27, 28, 36, 37, 41, 42, 46, 47, 48 were missing; 36, 37, 41, 43, 46, 47 implantation.

20 weeks after surgery, around implant no adverse reaction, fibrosis/fibrous capsule, tissue necrosis, fatty infiltration, granuloma, etc.
